Foreword

Step 1: Download the tool package and install the USB driver

Step 2: Flash the C200

Step 3: Program the serial number

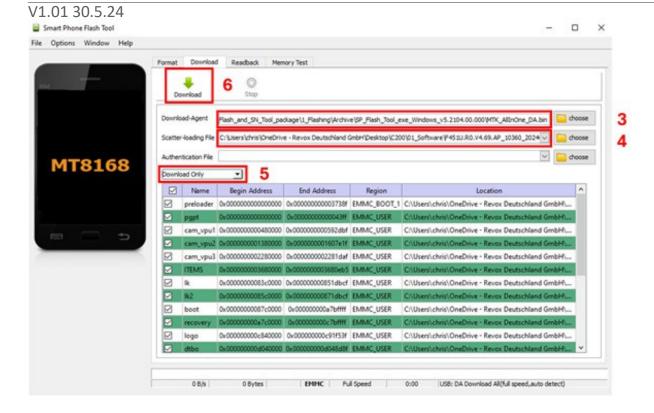
- 4. Select the current scatter file "MT8168_Android_scatter.txt" from the current SW release folder.
- 5. Select "Download only" so that the existing SN is not overwritten!
- 6. Then click on "Download."
- 7. Now connect the switched-off C200 to the computer using a USB cable. The flashing process should now start without further interaction; this is also displayed in the flashing tool.
- 8. After flashing, the "Download OK" message can be closed. If a correct SN was read out beforehand, the USB-C cable can be disconnected and the cover can be replaced. If an incorrect SN was detected, the USB-C cable can be disconnected and then proceed directly to step 3.

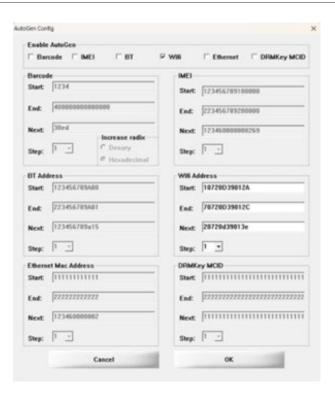
- 1. Switch off (shut down) the C200
- 2. Run "SN_Writer.exe" in the "03_SN_MAC_writer_tool" folder.
- 3. Under "Identify-Engineer-Enable AutoGen," check that the box next to "Wifi" is checked. Then close the window by clicking OK.

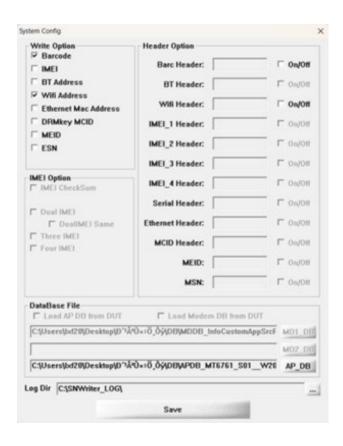
4. Now press "Config" and make sure that "Barcode" and "Wifi Address" are activated. Next, click on "AP_DB" to select the correct file, which is located in the folder F451U.R0.V4.69.AP_10360_20250918.zip folder under "\F451U.R0.V4.69.AP_10360_20240528\DB". Now save everything by clicking on "save."

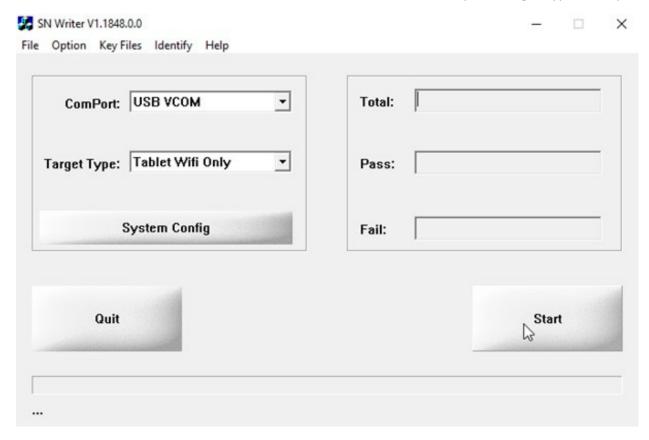
5. Ensure that "USB VCOM" is selected for ComPort and "Tablet Wifi only" for Target Type. Then press "Start."

6. Next, enter the correct serial number in the "Barcode" field. The WiFi address is generated automatically by the tool. Now click "OK" and connect the C200 to the USB-C cable.
